<p>CARLO GAVAZZI</p> <p>CARLO GAVAZZI SPACE SpA</p>	<h1>AMS02-TCS</h1>	<p>DOC N°: AMSTCS-RP-CGS-007</p> <p>ISSUE : 1 DATE: 17.10.2008</p> <p>PAGE : 1 of 21</p>
--	--------------------	---

INSPECTION REPORT

WAKE RADIATOR 22-AMS-000.00.00

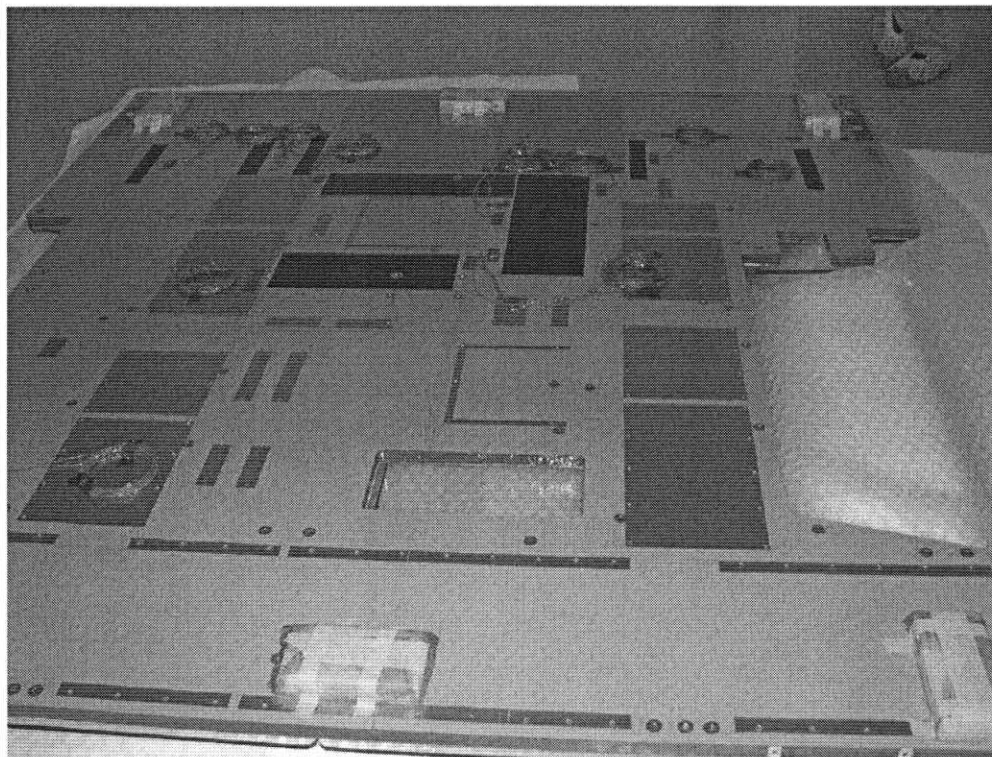
- a) Free of dust and other particles**
- b) Free from finger-prints**
- c) Presence of some adhesives and of greasy remains has been noticed . Some stains and spots can be noticed on the surface. Final cleaning is required.**
- d) No scratches or deformation and cracks have been noticed**
- e) No visible corrosion or moisture have been noticed**

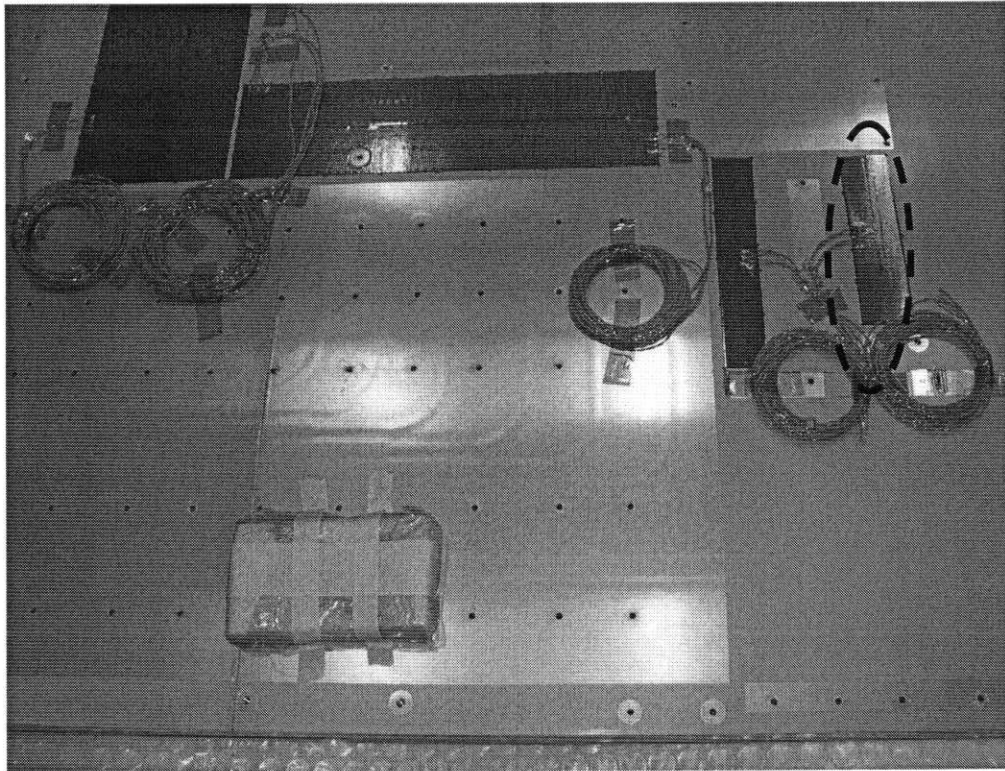
4) At a first look on the radiator surface the path followed by the internal heat pipes is clearly visible (probably due to the surface treatment)

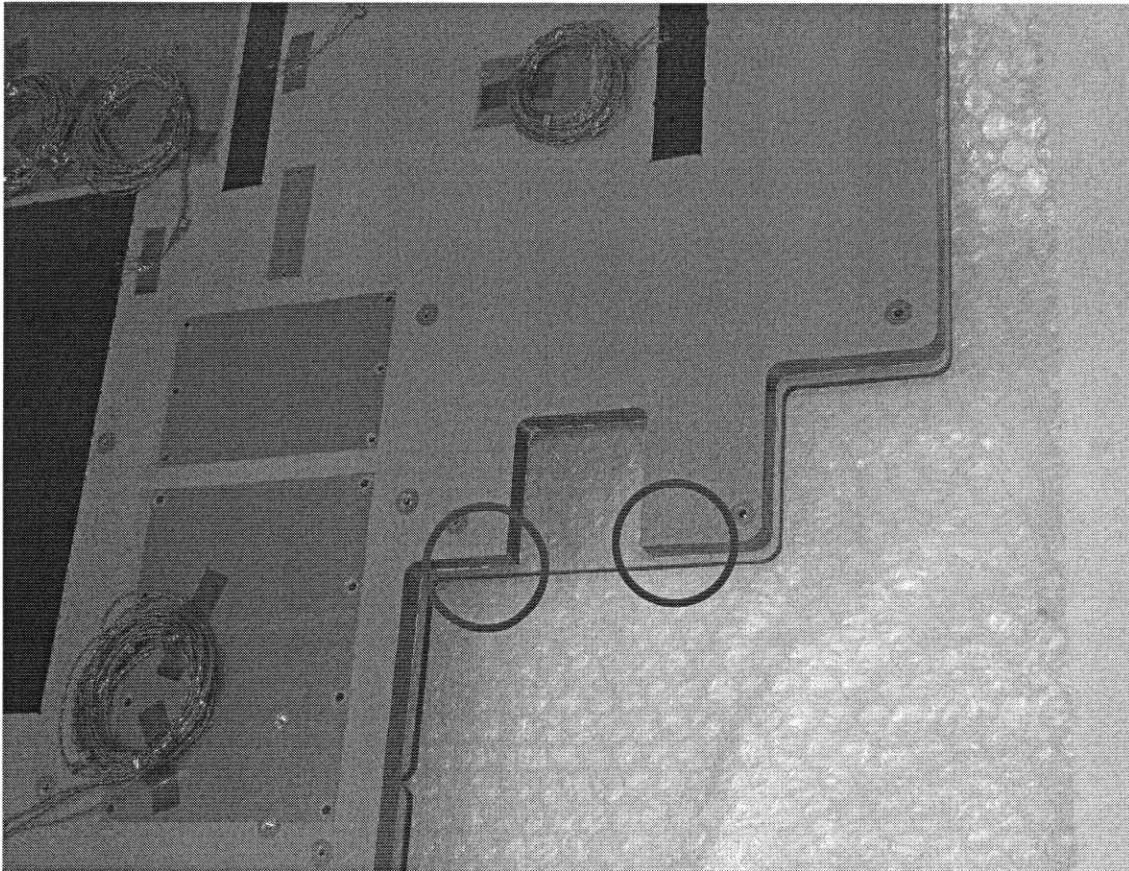
5) The cut out added to the WAKE radiator according to ECO 00129 has very sharp edges and it will require a recovery activity. (NCR-TCS-CGS-C-003)

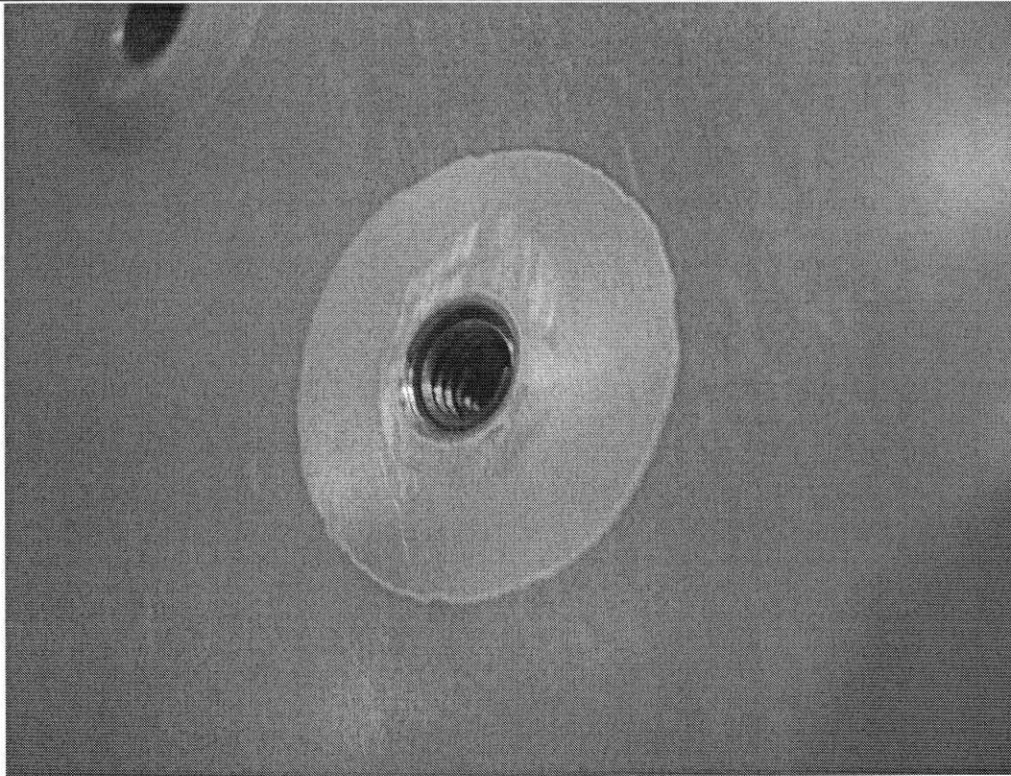
6) The helicoils which have been inserted according to the AIDC internal procedure have not been cleaned and they are red (NCR-TCS-CGS-C-004)

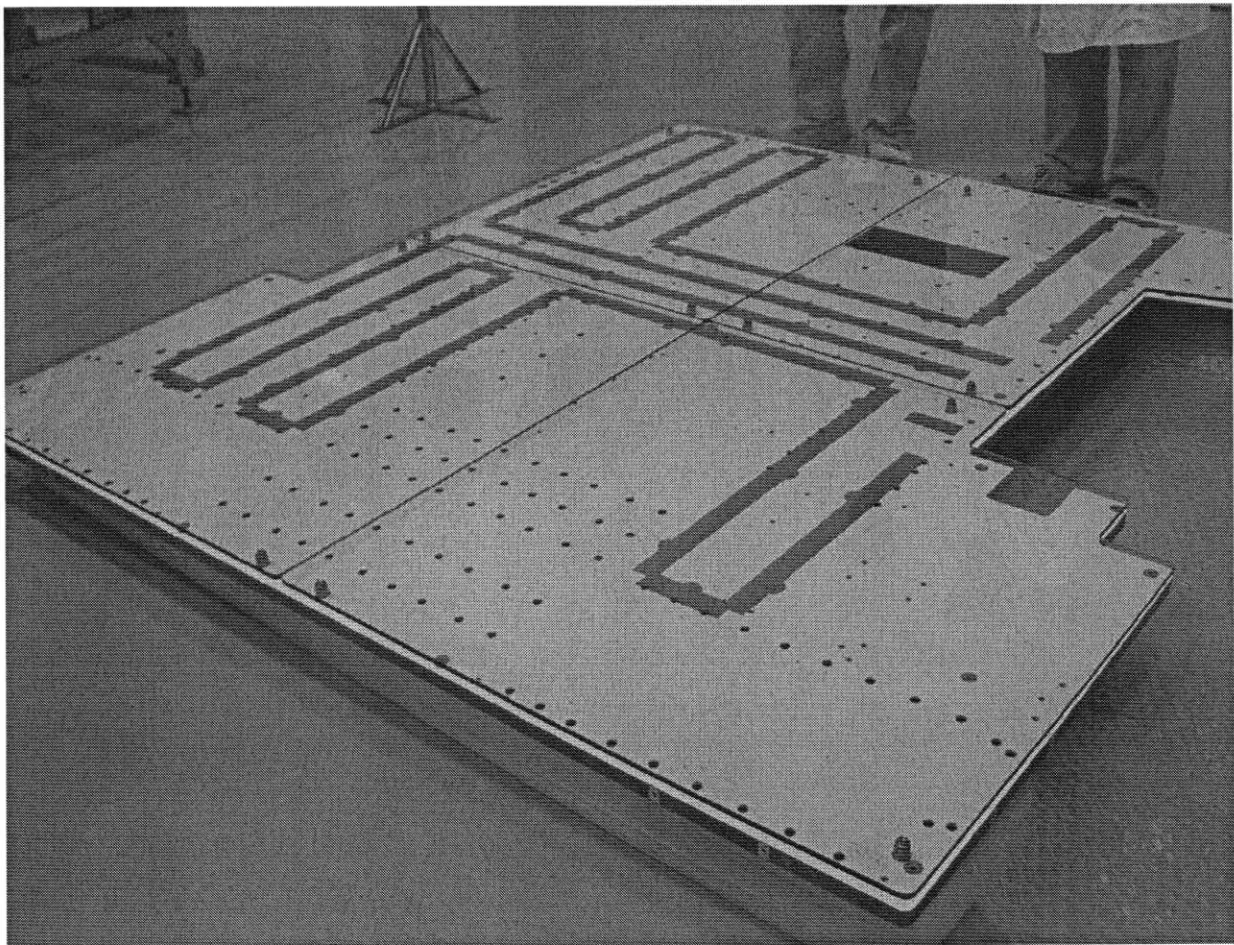
The Paint SG121FD results to be uniformly applied and there were no release of visible particles. It results rough at the contact.

Acc. to the drawing the paths where the heat pipes have to be glued are treated with alodine.

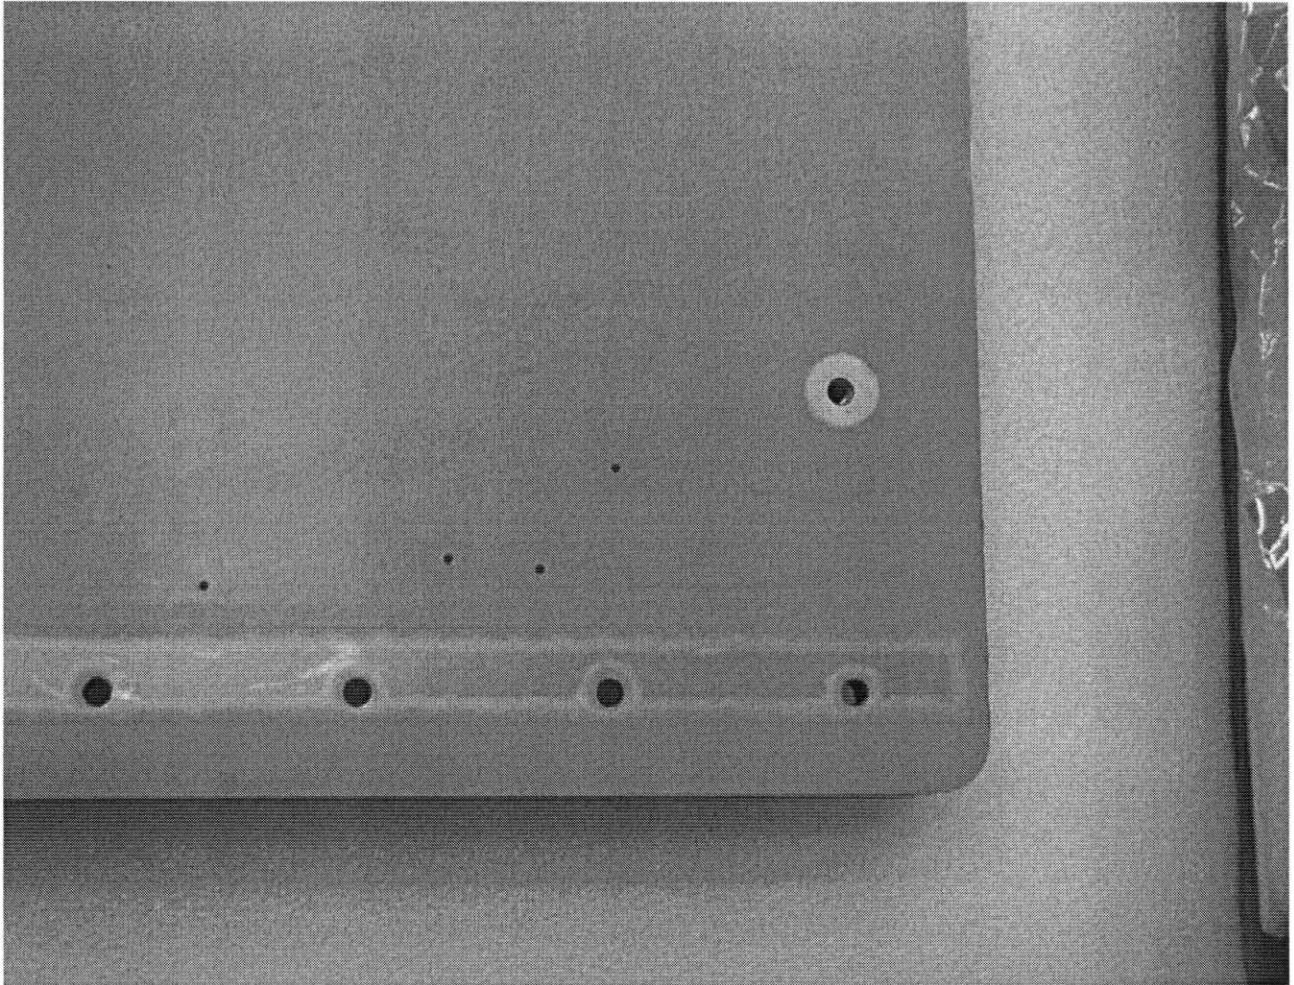
- a) Free of dust and other particles**
 - b) Free from finger-prints**
 - c) Presence of some adhesives and of greasy remains has been noticed. Some stains and spots can be noticed on the surface. Final cleaning is required.**
 - d) No scratches or deformation and cracks have been noticed**
- The reworked area , is shown in the picture below.**

Apart from the four injection holes no trace of damages has been noticed.

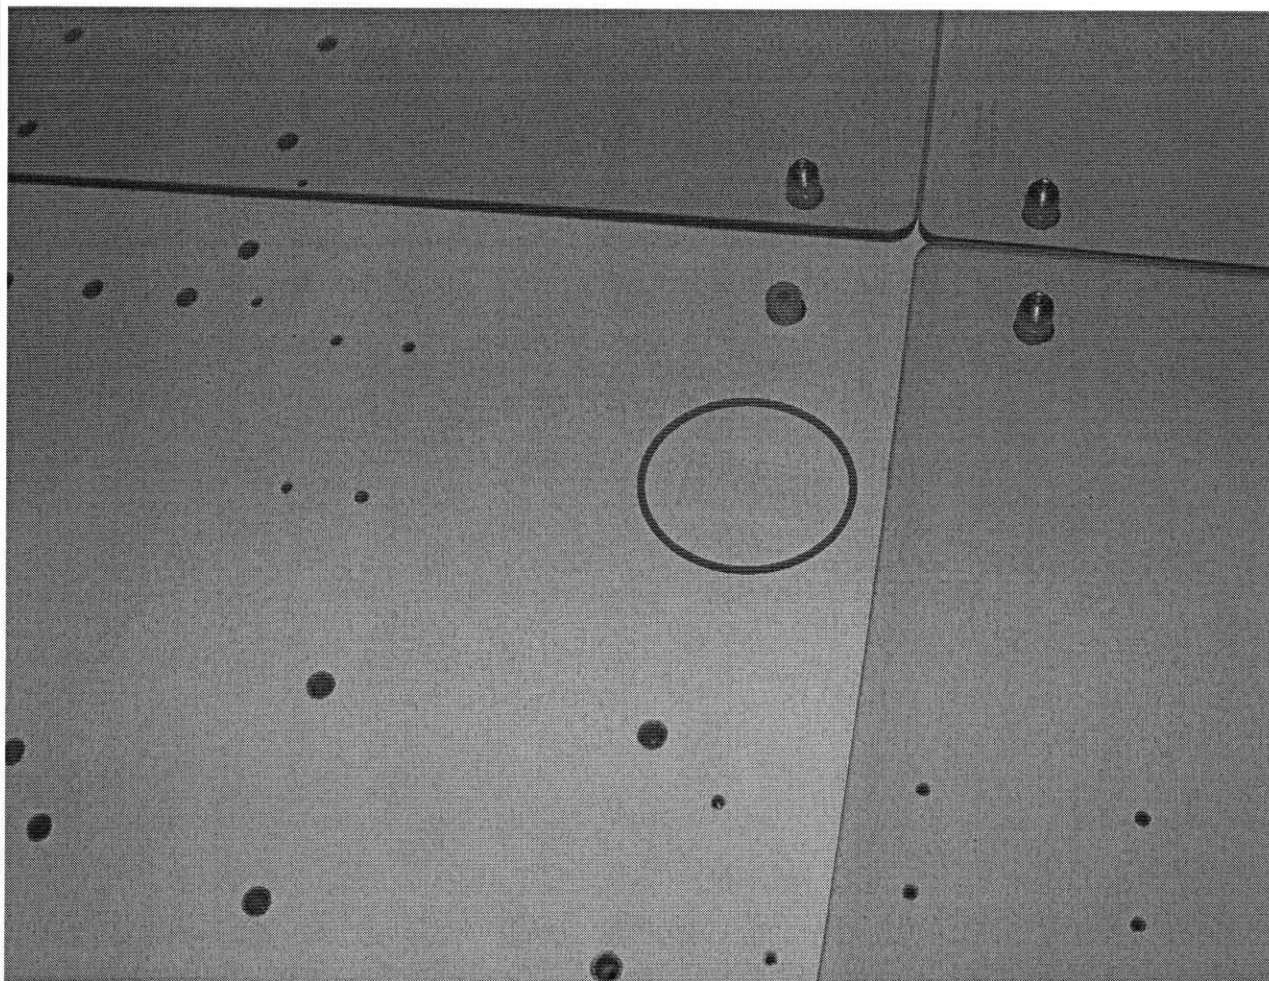
The reworked area documented is shown in the picture below

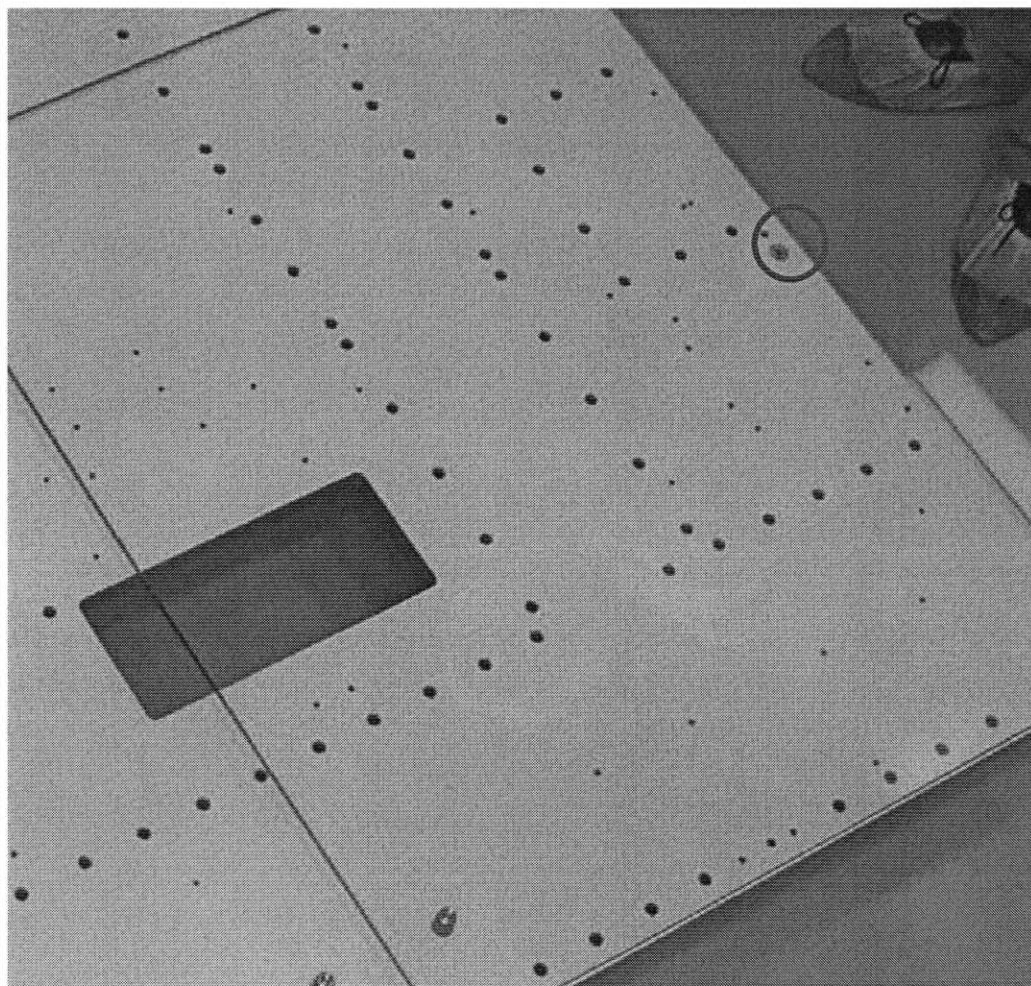
2) The area around one hole of the RAM Radiator which had to be treated with

alodine for the bonding strap connection has been painted with SG121FD white paint (NCR-TCS-CGS-C-004)

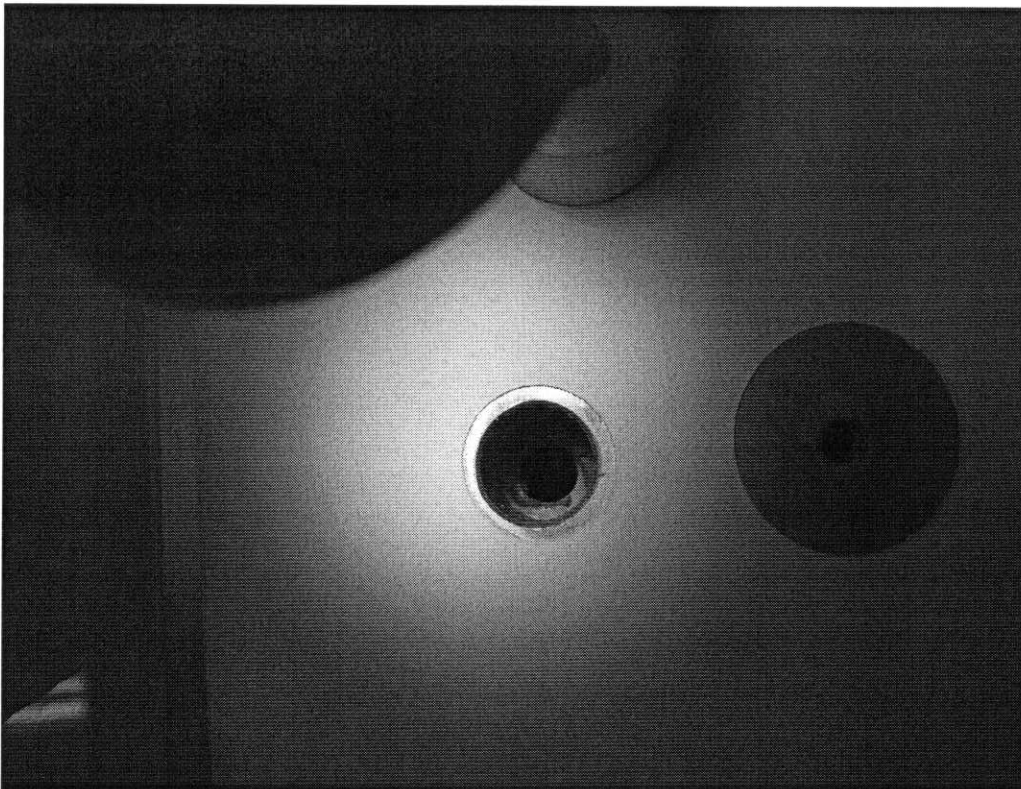
- 3) *All the holes from this side are not cleaned and in particular it has been noticed the presence of many pieces of glue and metal filings inside . (NCR-TCS-CGS-C-004)*

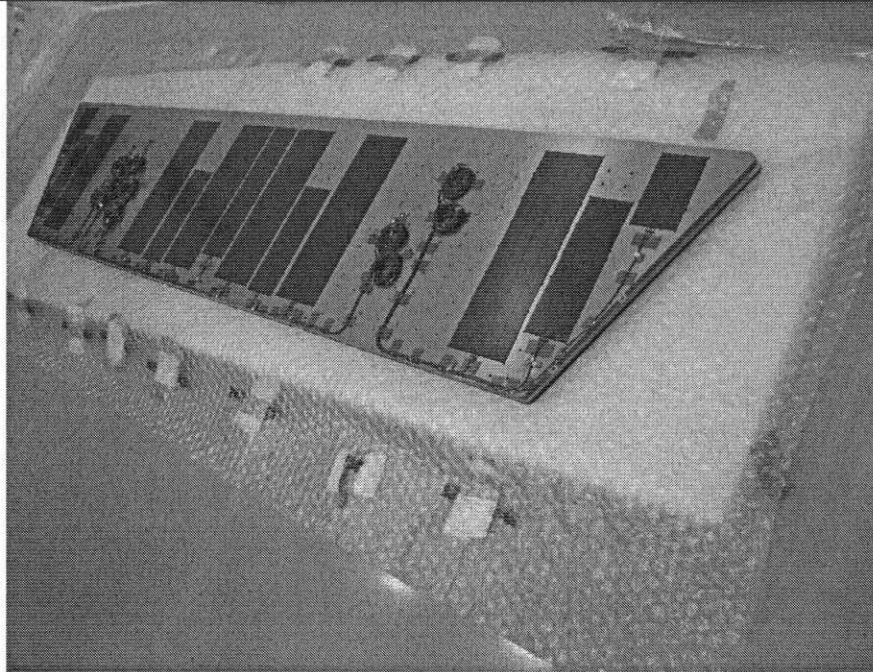
3) The Heaters on the radiator surface show some defects

a) Most of the heaters present a "half-moon" debonding area in correspondance of the soldered wires.

b) Some of the heaters present Single bubbles

c) Some of the heaters present Diagonal wrinkles

The heaters which present a debonding area are shown in NCR-TCS-CGS-C-007

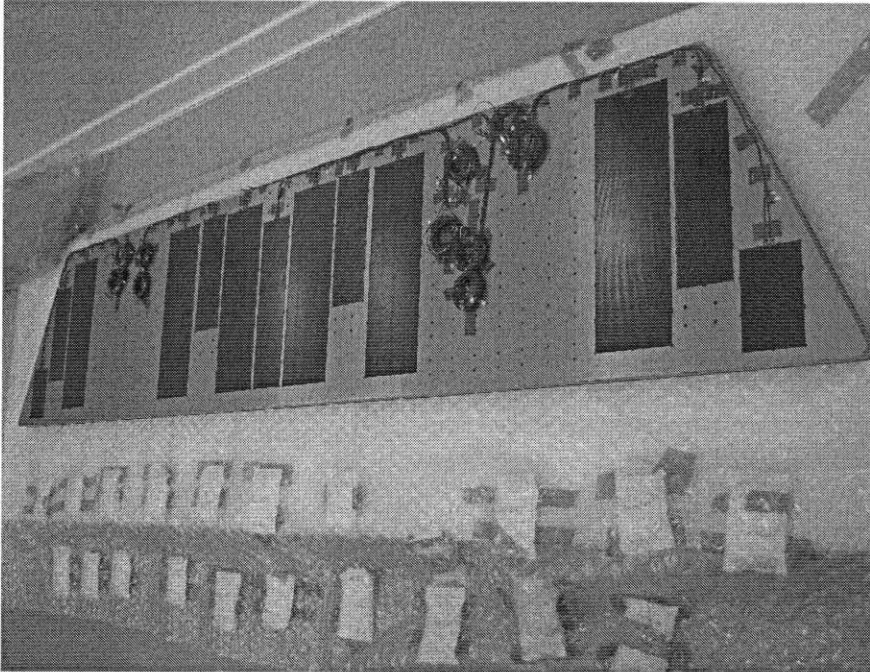
2) The surface treatment is very different from the surface treatment of the Tracker Radiator S/N 2. (NCR-TCS-CGS-C-002)

While the S/N 2 is evidently gold alodined the S/N 1 present a different aspect

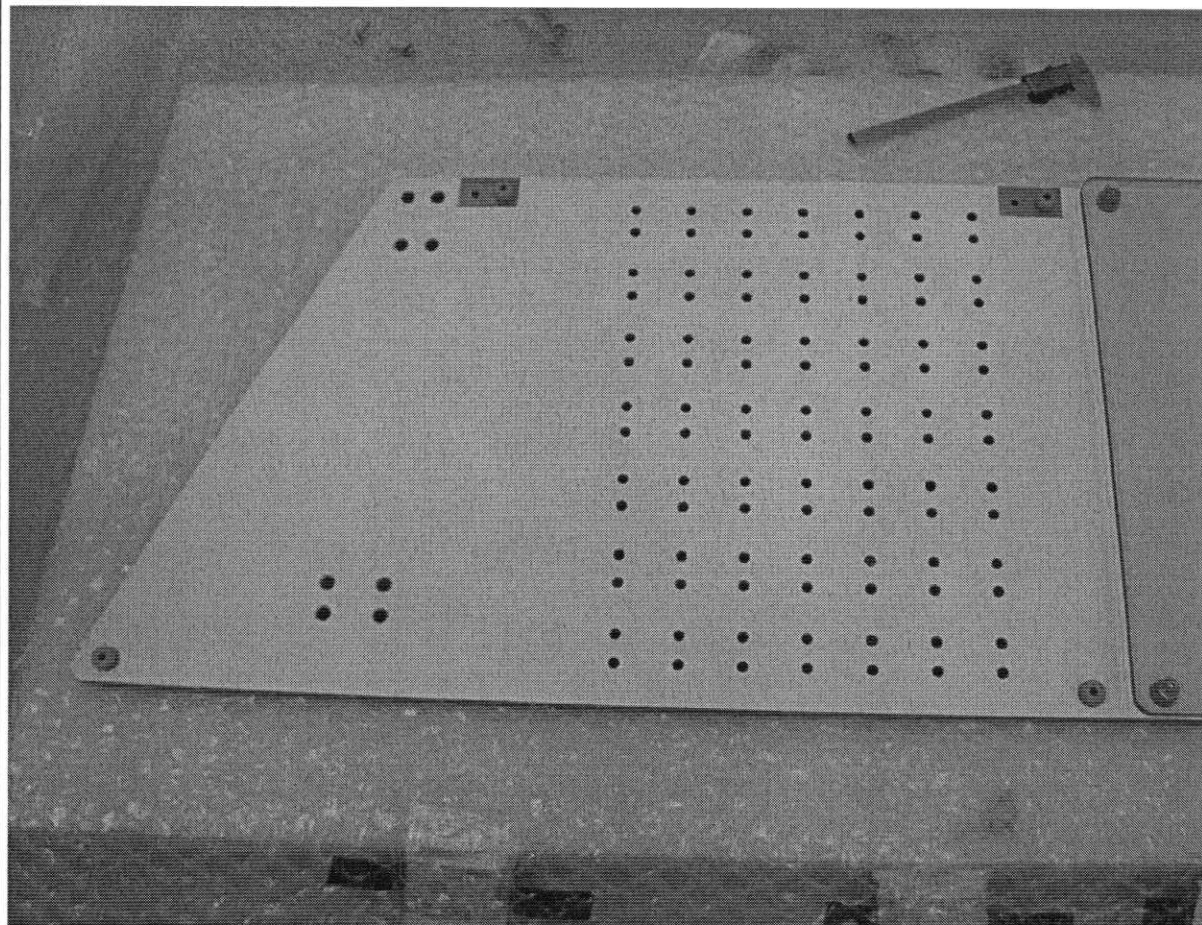
2) All the holes from this side are not cleaned inside and in particular it has been noticed the presence of many pieces of glue
